Assessment of Steel Structure Connections After Fire Exposure Through Bolt Torque Testing and Dye Penetrant Inspection

Abstract. In 2022, a significant fire incident occurred at a steel tower structure in an industrial plant in Lampung, Indonesia, raising serious concerns about the structural integrity and serviceability of the affected steel framework. Fire exposure is known to alter the properties of steel, weaken bolt pretension, and cause defects in welds, underscoring the necessity of thorough post-fire assessments. Nondestructive testing (NDT) methods are crucial in evaluating the safety and stability of structures after fire exposure, as they can detect potential weaknesses without compromising the material further. This study employed two field inspection methods: the bolt torque test and dye penetrant inspection (DPI). A total of 21 bolts (Tor-1 to Tor-21) were tested for their integrity. The results showed that, while all bolts were present, more than half were found to be loosened, indicating the need for re-tightening to restore the specified torque and maintain the required preload for the bolted connections. In addition, 20 welded joints (DP-1 to DP-20) were examined

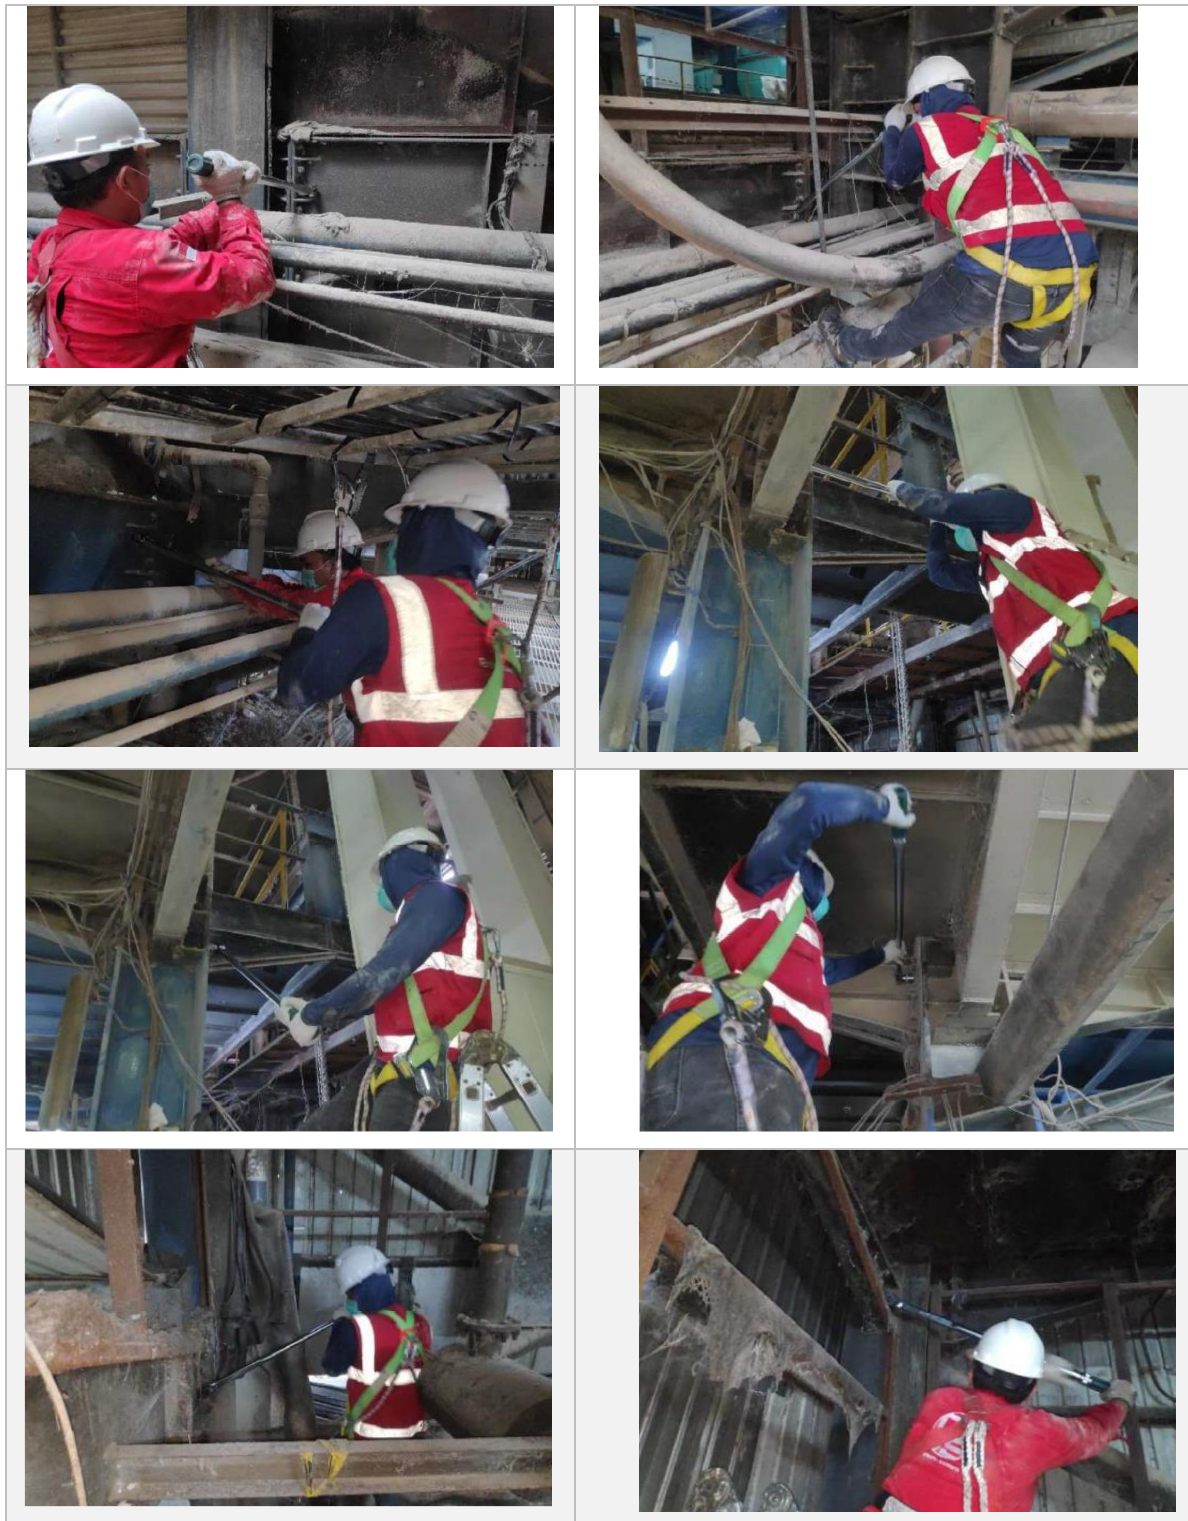
Figure 5. Bolt torque testing (beam and column structure)

Field testing was conducted on 21 bolt samples (Tor-1 to Tor-21) from the steel tower structural connections. Results indicated that all bolts were complete, with no missing components such as washers or lock nuts in Figure 5. However, it was observed that a significant number of bolts were in a loosened condition during inspection. Corrective action in the form of re-tightening was immediately performed on-site to ensure each bolt achieved the torque values in accordance with the standard.

This phenomenon can be attributed to thermal effects during the fire. At elevated temperatures, steel bolts undergo thermal expansion, reducing their initial pretension. Upon cooling, the pretension does not fully recover, leaving the bolts in a loosened state.

In addition to thermal expansion, bolt loosening may also be explained by thermal creep, where prolonged exposure to high temperatures induces plastic deformation in the bolts. Another contributing factor is uneven heat distribution at the joint, which leads to imbalanced tensile forces across bolts in Figure 6. Nevertheless, the retightening process

demonstrated that these bolts could still be restored to the required torque values, indicating that their threads and tensile strength were not significantly degraded.

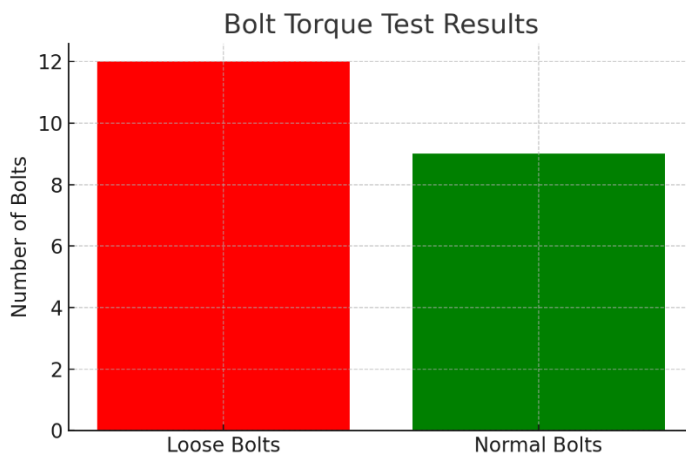
Figure 6. Graph of bolt torque test result (beam and column structure)

The bolt torque test results revealed that most bolted joints retained acceptable torque levels according to design standards, yet several bolts displayed torque values below the minimum threshold.

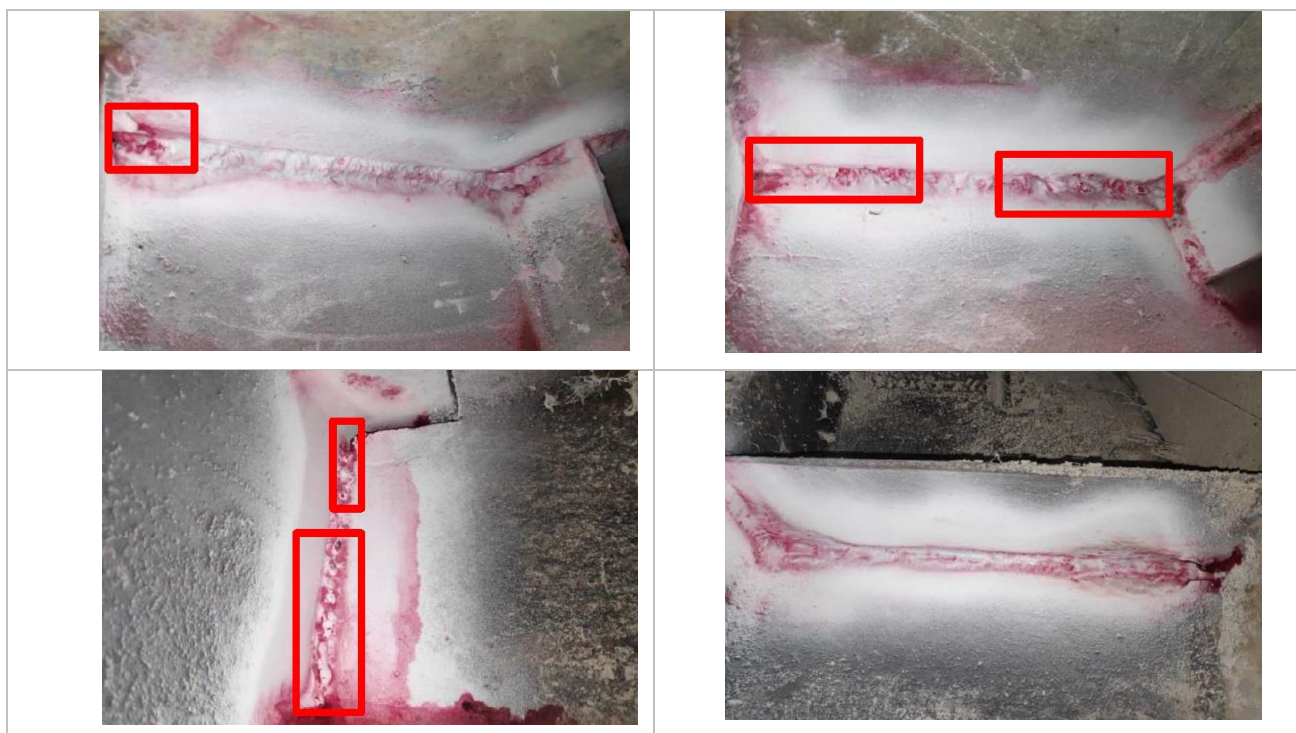
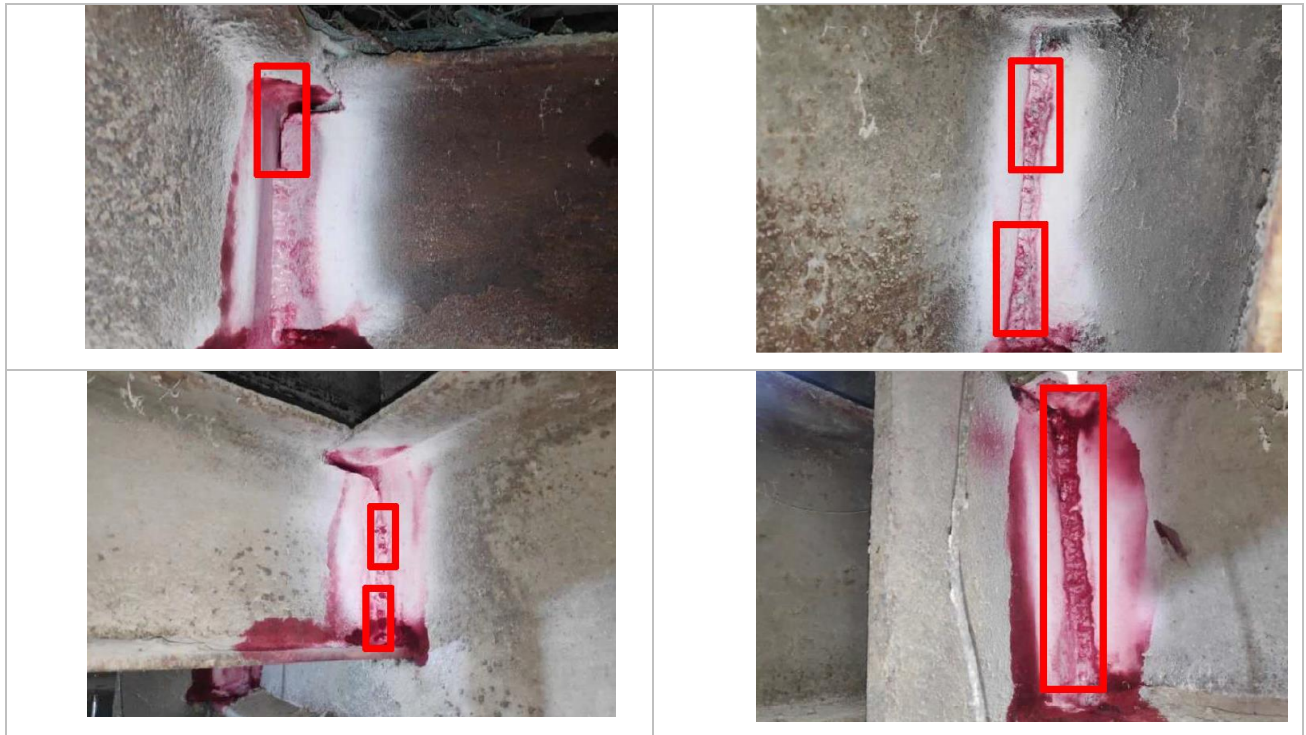
Figure 7. Dye penetrant inspection (beam and column structure)

The dye penetrant inspection (DPI) results indicated that most weld joints exhibited no relevant defect indications in Figure 7 and Figure 8. Some minor rounded porosity indications (< 5 mm) were detected but remained within the acceptance limits specified in ASME Sec V Article 6. The absence of linear cracks exceeding 1.5 mm strongly suggests that the welds were not severely compromised by fire exposure.

The observed porosity indications can be attributed to two main factors. First, non-uniform cooling following the fire may have induced thermal stresses that generated microvoids on the weld surface. Second, surface oxidation caused by fire exposure could have influenced defect visibility, although the findings still fell within safe limits. Consequently, the welded joints are considered serviceable, although periodic monitoring is recommended to mitigate the risk of long-term degradation.

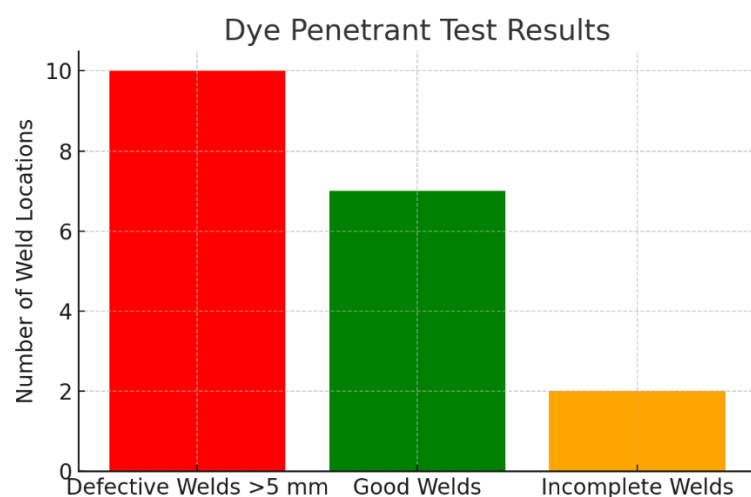
Figure 8. Graph of dye penetrant test result

The test was conducted on 20 weld locations (DP-1 to DP-20). The inspection results showed:

1. Many welds exhibited surface defects exceeding 5 mm in length, such as DP-1, DP-2, DP-3, DP-8, DP-11, DP-12, DP-13, DP-16, DP-17, and DP-18.
2. Several welds were in acceptable condition with no relevant indications, including DP-4, DP-5, DP-7, DP-9, DP-10, DP-14, and DP-19.
3. Cases of incomplete or imperfect welds were identified at DP-6 and DP-20, which represent significant non-conformities in weld quality.

On the other hand, DPI results revealed a more varied condition in welded joints. Many locations showed weld defects exceeding 5 mm, which according to acceptance criteria are considered relevant and require further action. The presence of incomplete or imperfect welds at DP-6 and DP-20 is particularly concerning, as it may significantly reduce joint capacity. Although some welds remained acceptable, the predominance of defect indications highlights a decline in weld quality after the fire, likely caused by thermal stresses, oxidation, or fabrication imperfections.

Taken together, these findings indicate that bolted joints can remain reliable with corrective measures, while welded joints demand more thorough evaluation, local repairs, or even rewelding at critical points. Thus, the overall integrity of the steel tower structure can be maintained, but special attention to welded connections must be prioritized in the post-fire rehabilitation program.
